**INTERIM REMEDIAL MEASURES
COMPLETION REPORT
PASCO LANDFILL
PASCO WASHINGTON**

**February 4, 1998
Project No. 16921**

**Prepared for:
Pasco Landfill PLP Group**

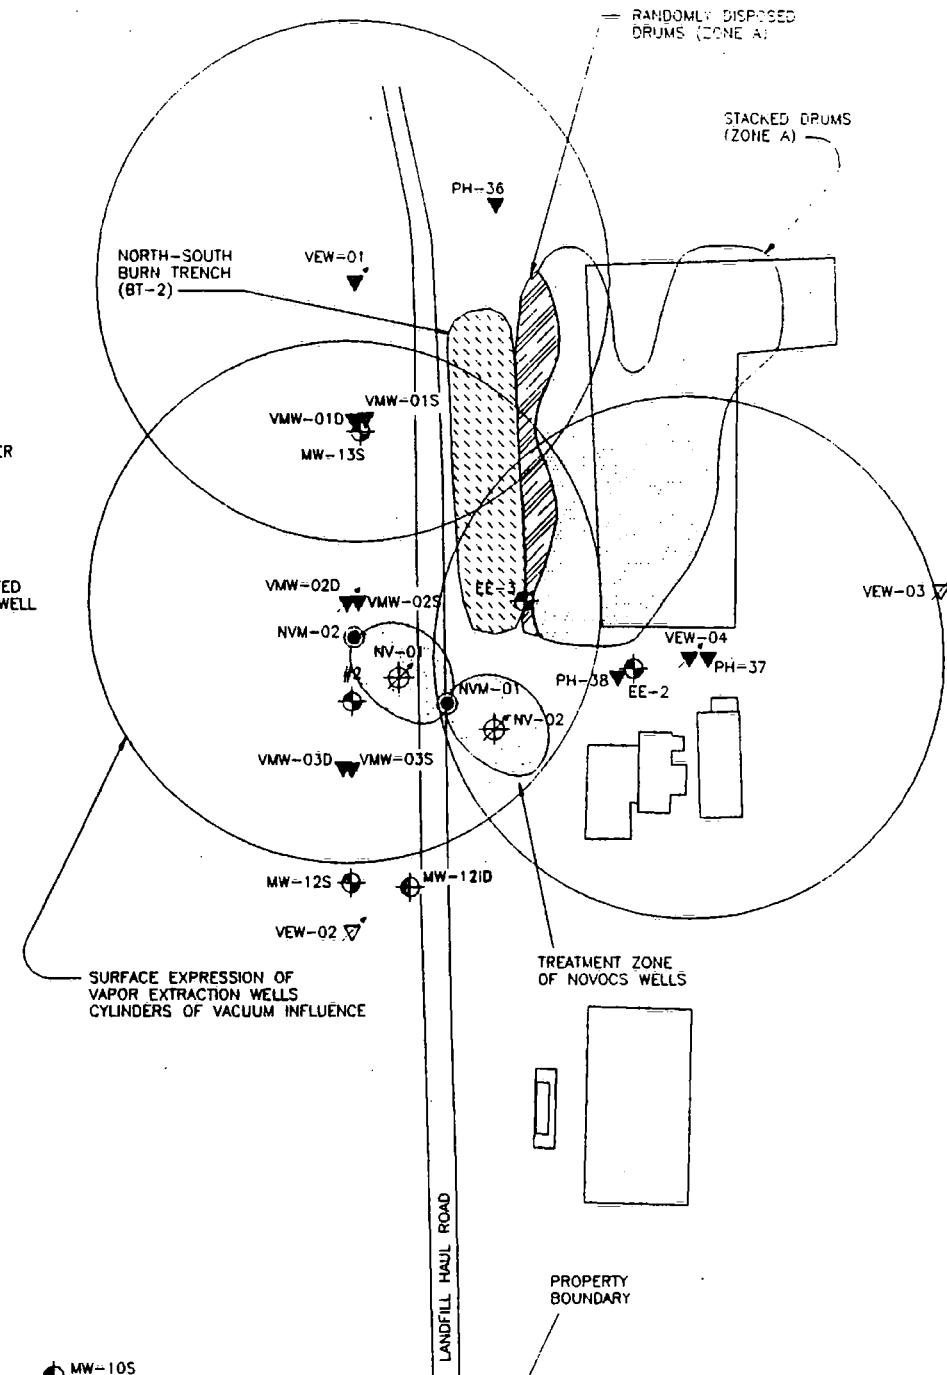
TITLE:
Soil Vapor Extraction
and NOVOCs System Configuration
Pasco Landfill IRM

VAPOR EXTRACTION CYLINDERS OF VACUUM INFLUENCE
CENTERED ON VEW-01, VMW-02D, VEW-04.
ZONE OF INFLUENCE OF NOVOCs EXTRACTION
WELLS CENTERED ON NV-01 AND NV-02.

Radius of influence testing was conducted by measuring the baseline vacuum/pressures at several vapor monitoring points around the site (Figure 1). Baseline measurements were taken on the mornings of May 15 and June 2 after the SVE system had been shut down for 8 hours to return the vadose zone to natural conditions. Table 1 is a summary of radius of influence testing. These data indicate that the operating SVE system is inducing greater radii of influence than was expected from the pilot test data. Based on the data collected from monitoring points VMW-01S, VMW-02S, and VMW-03S it appears that the Touchet formation is acting as an effective barrier to air flow short circuiting from the surface.

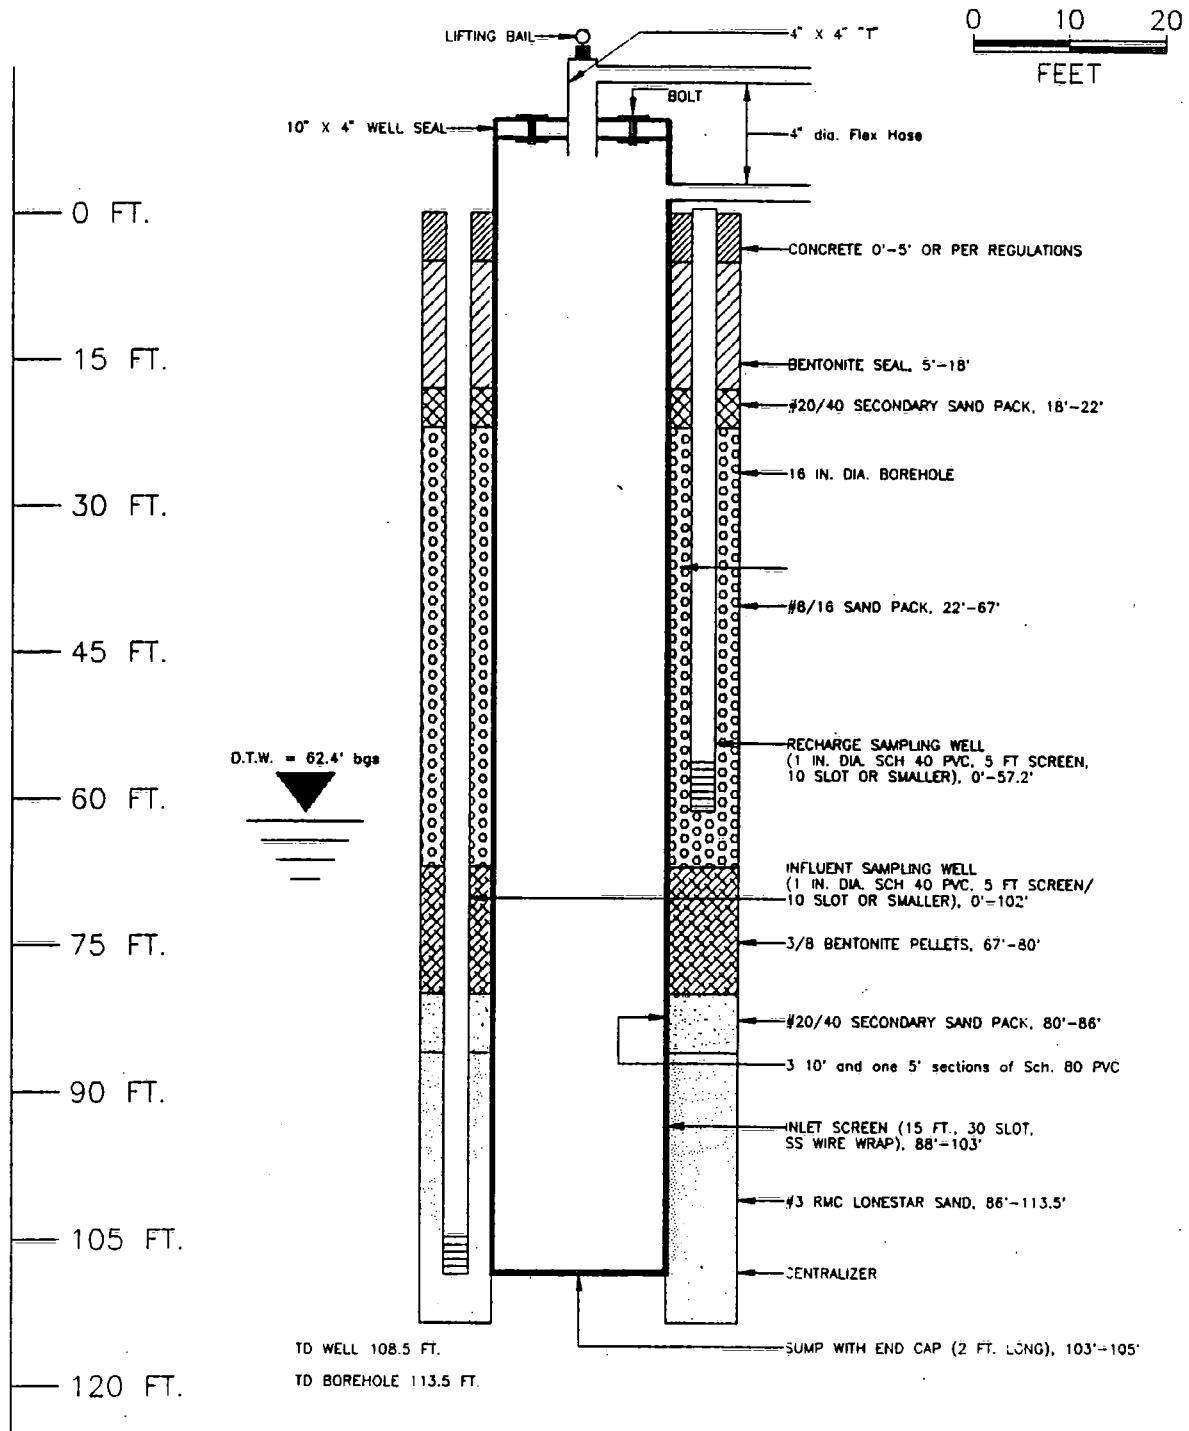
TITLE:
NV-2 Construction
Diagram
Pasco Landfill IRM

57
 COUNTY: FRANKLIN
 LOCATION: NE 1/4 NE 1/4 Soc 28 Twp 9N R 30E
 STREET ADDRESS OF WELL: Pasco Landfill
307 W. Court, Pasco, WA
 WATER LEVEL ELEVATION: 57.5
 GROUND SURFACE ELEVATION: N/A
 INSTALLED: 3-26-97
 DEVELOPED: no

Installation of the NoVOCs in-well air stripping system began with the drilling of two 16-inch borings. The NoVOCs wells and monitoring piezometers were installed in these borings. The well completion diagrams are contained in Appendix A. After installation of the treatment wells was completed, Philip installed two monitoring wells to measure the treatment zone of the two-well NoVOCs system. NVM-01 was installed at the midpoint between the two NoVOCs wells, and NVM-02 was installed 45 feet from NV-01, transverse to the groundwater flow direction.
